Post Construction Failure Analysis of Road Pavements in Ghana.

Abstract

The current Koforidua By-Pass is a 9 kilometer four lane dual carriageway which was fully funded by the government of Ghana. The road is a major arterial serving communities linking it and providing an alternative south –north connection which avoids the congested Central Business District (CBD) of Koforidua, thereby easing traffic congestion and thus reducing travel time for motorists. This Koforidua highway is a surface dressed wearing course with a vegetative median of 2 meters width. The total carriageway width is 14.6 meters. The north and south bound lanes are 7.3 meters apiece with shoulders of 2 meters on both sides and drainage structures at some selected sections. Four critical intersections on the road have been signalized to facilitate traffic management. Street lights were virtually installed at every 40 meter intervals along the median for safety and security of motorists and pedestrians.

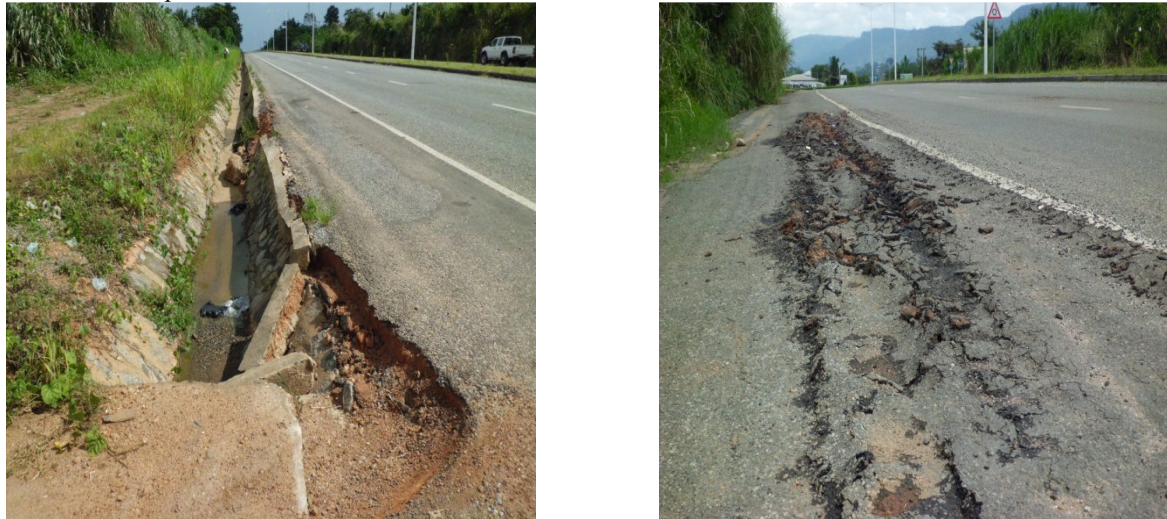
Fig 1: A 3- month old road surface showing poor drainage works and premature road surface failure.

Massive shoving, rutting, depressions and potholes as well as longitudinal cracks were mostly observed on the wheel path of the inner lane of the pavement surface. This lane was adjacent to the median. There was seepage of water from the subgrade and some fractured bedrock to the road surface near the median.

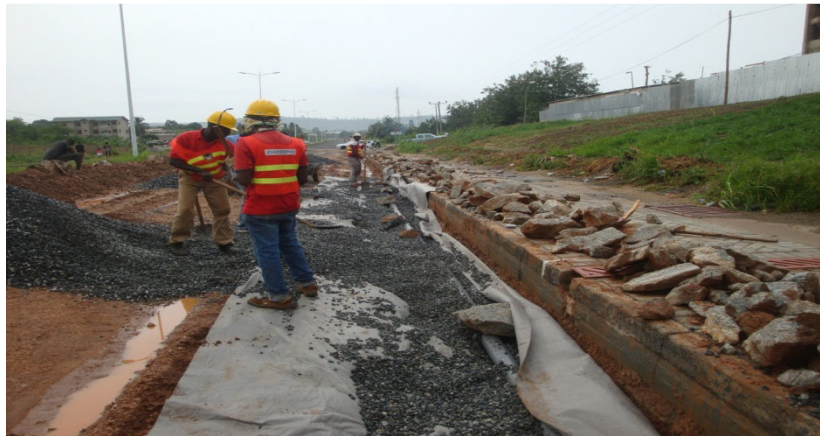
Fig 2: Use of geotextile material at ch 880

Maintenance works started three months after the road pavement was open to vehicular traffic to remedy most of the pavement defects to ensure safety on the roadway. The defective sections on the roadway were excavated to the subgrade formation. Geotextile material was installed at CH 880 as shown the figure 3. 100 mm boulders were placed on the geotextiles fabric. It was then compacted with a 10 ton vibratory roller to a depth of 0.5 meters.

Crushed rock aggregates (0 -40 mm size) were placed on the compacted boulder layer and were subsequently compacted. Crushed granite aggregates mixed with natural gravels were used as a sub -base layer and were compacted to a thickness of 200 mm.

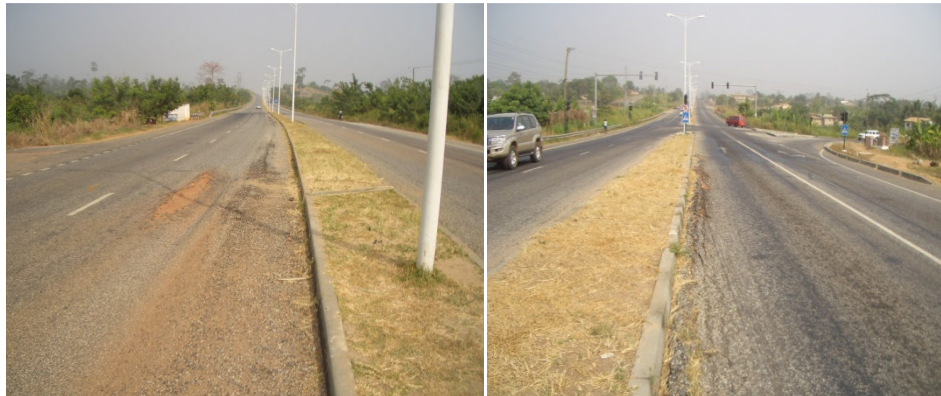
Road defect (pothole) Shoving and Longitudinal grooves

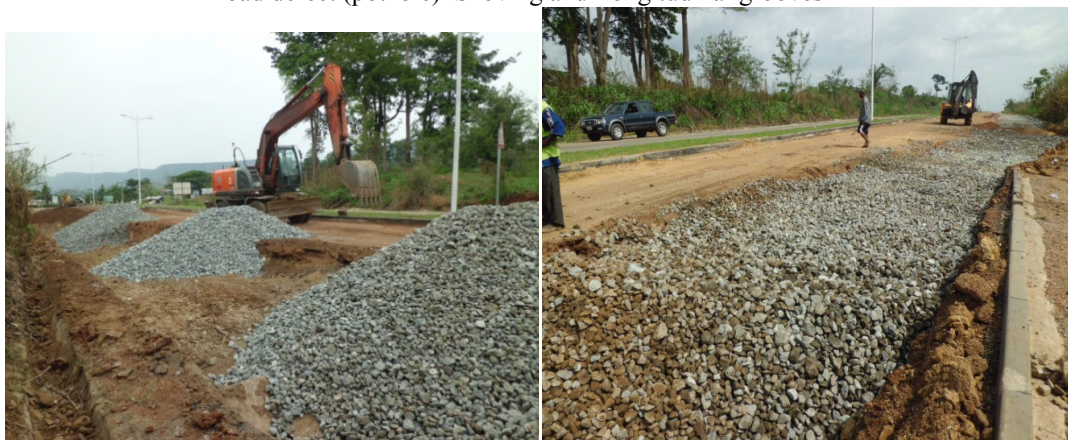
During remedial works (Placement of crush rock base material)

The sub-base materials were stabilized with 10 percent cement to increase its CBR and compressive strength values. The 200 mm thick stabilized material was used as a base layer. Unfortunately the wearing course is still surface dressed instead of hot asphaltic cement concrete layer.
